WINDOW REPAIRS: OUTLINE PROCESS

Westminster Hall Lantern

Windows - Installation  
Indents to Mullions - Internally

| Project | PW.WH3 | No | C3207 |

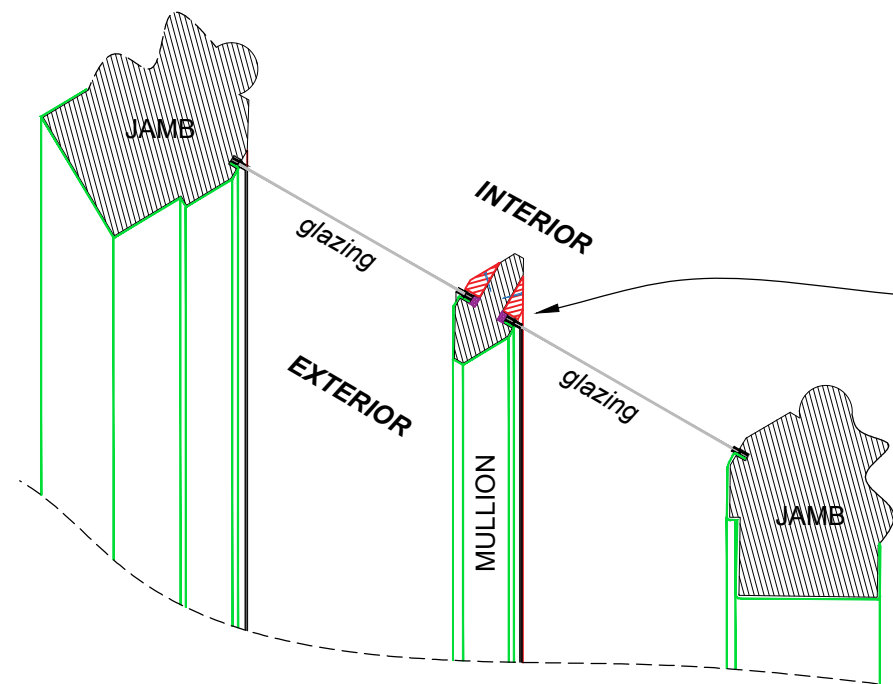
C3207  
1  
1:10 - C - C

- Typical Lantern Window Mullion and Jamb**
- Existing mullions to be cut to allow new quarter sawn seasoned oak strips (or 'beads'), shown red, to be fitted.
  - To be cut around ferramenta: existing locations to be reused; Dolmen to liaise with Reyntiens Glass Studio. Allow for additional cutting out of existing sockets to accommodate longer ferramenta, approx 30% of total.
  - Design is intended to simplify process of installing and removing glazing, for this installation and any future works, and to repair damaged arris and help compress glazing joint / sealant.

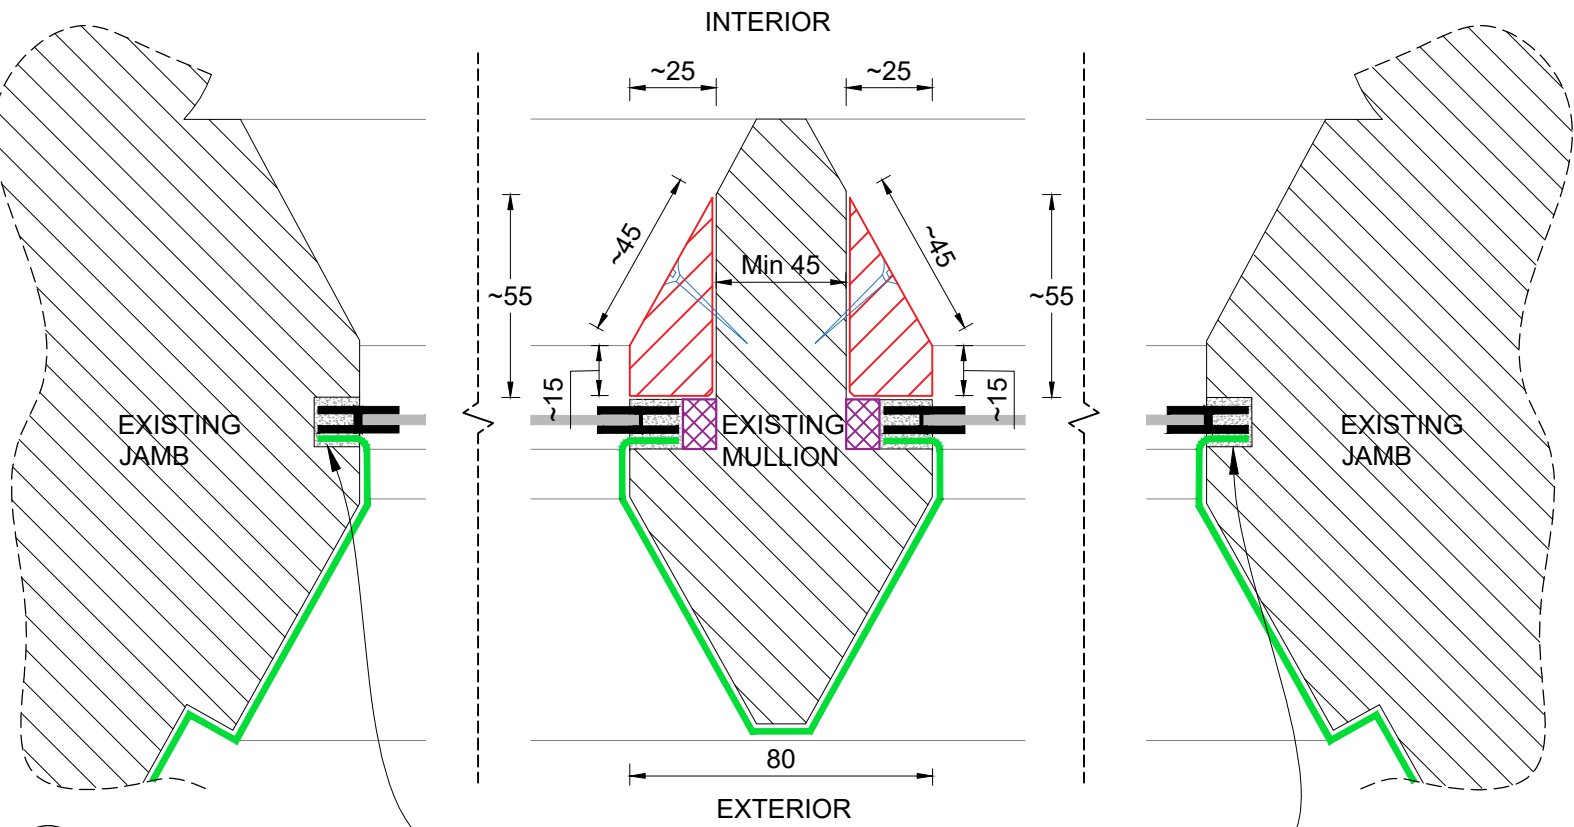
C3207  
2  
1:2 - C-C

Further routing of jamb rebates subject to Reyntiens comment and trial installation. See DIA drawings 3201 and 3202.

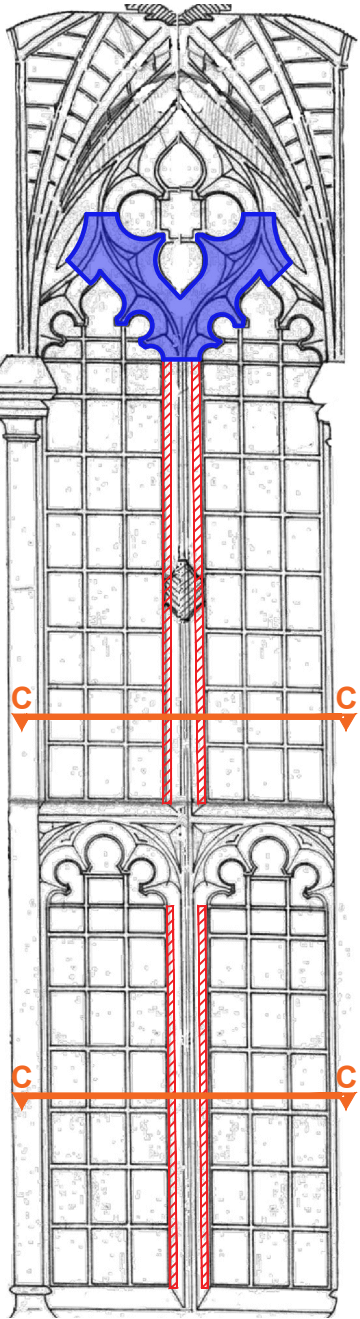
Typical Elevation, Internal  
(Six sides total)

- New silicone bronze slot-head screw fixings, countersunk flush. Allow for length 40mm: submit proposals.
- External lead dressing (indicative only, refer to DIA lead work drawings).
- New oak indent strips ('beads') to edges of mullions.
- N.B: Indent to internal face of tracery heads. See DIA Drawing 3210.
- Rebate cut out and not indented: additional space for window installation.

**Note on oak finish:** new oak is to be stained to match the colour of the existing oak. Submit samples.
