**DONALD INSALL ASSOCIATES LIMITED**  
12 Devonshire Street London W1G 7AB Tel: 020 7245 9888 Email: london@insall-architects.co.uk

**Job** Westminster Hall Conservation Project  
**Title** CLEANING AND REPAIR WORKS TO TIMBER ROOF TRUSSES  
BAY 3 - NORTH

| No | 2108 | Rev | F |

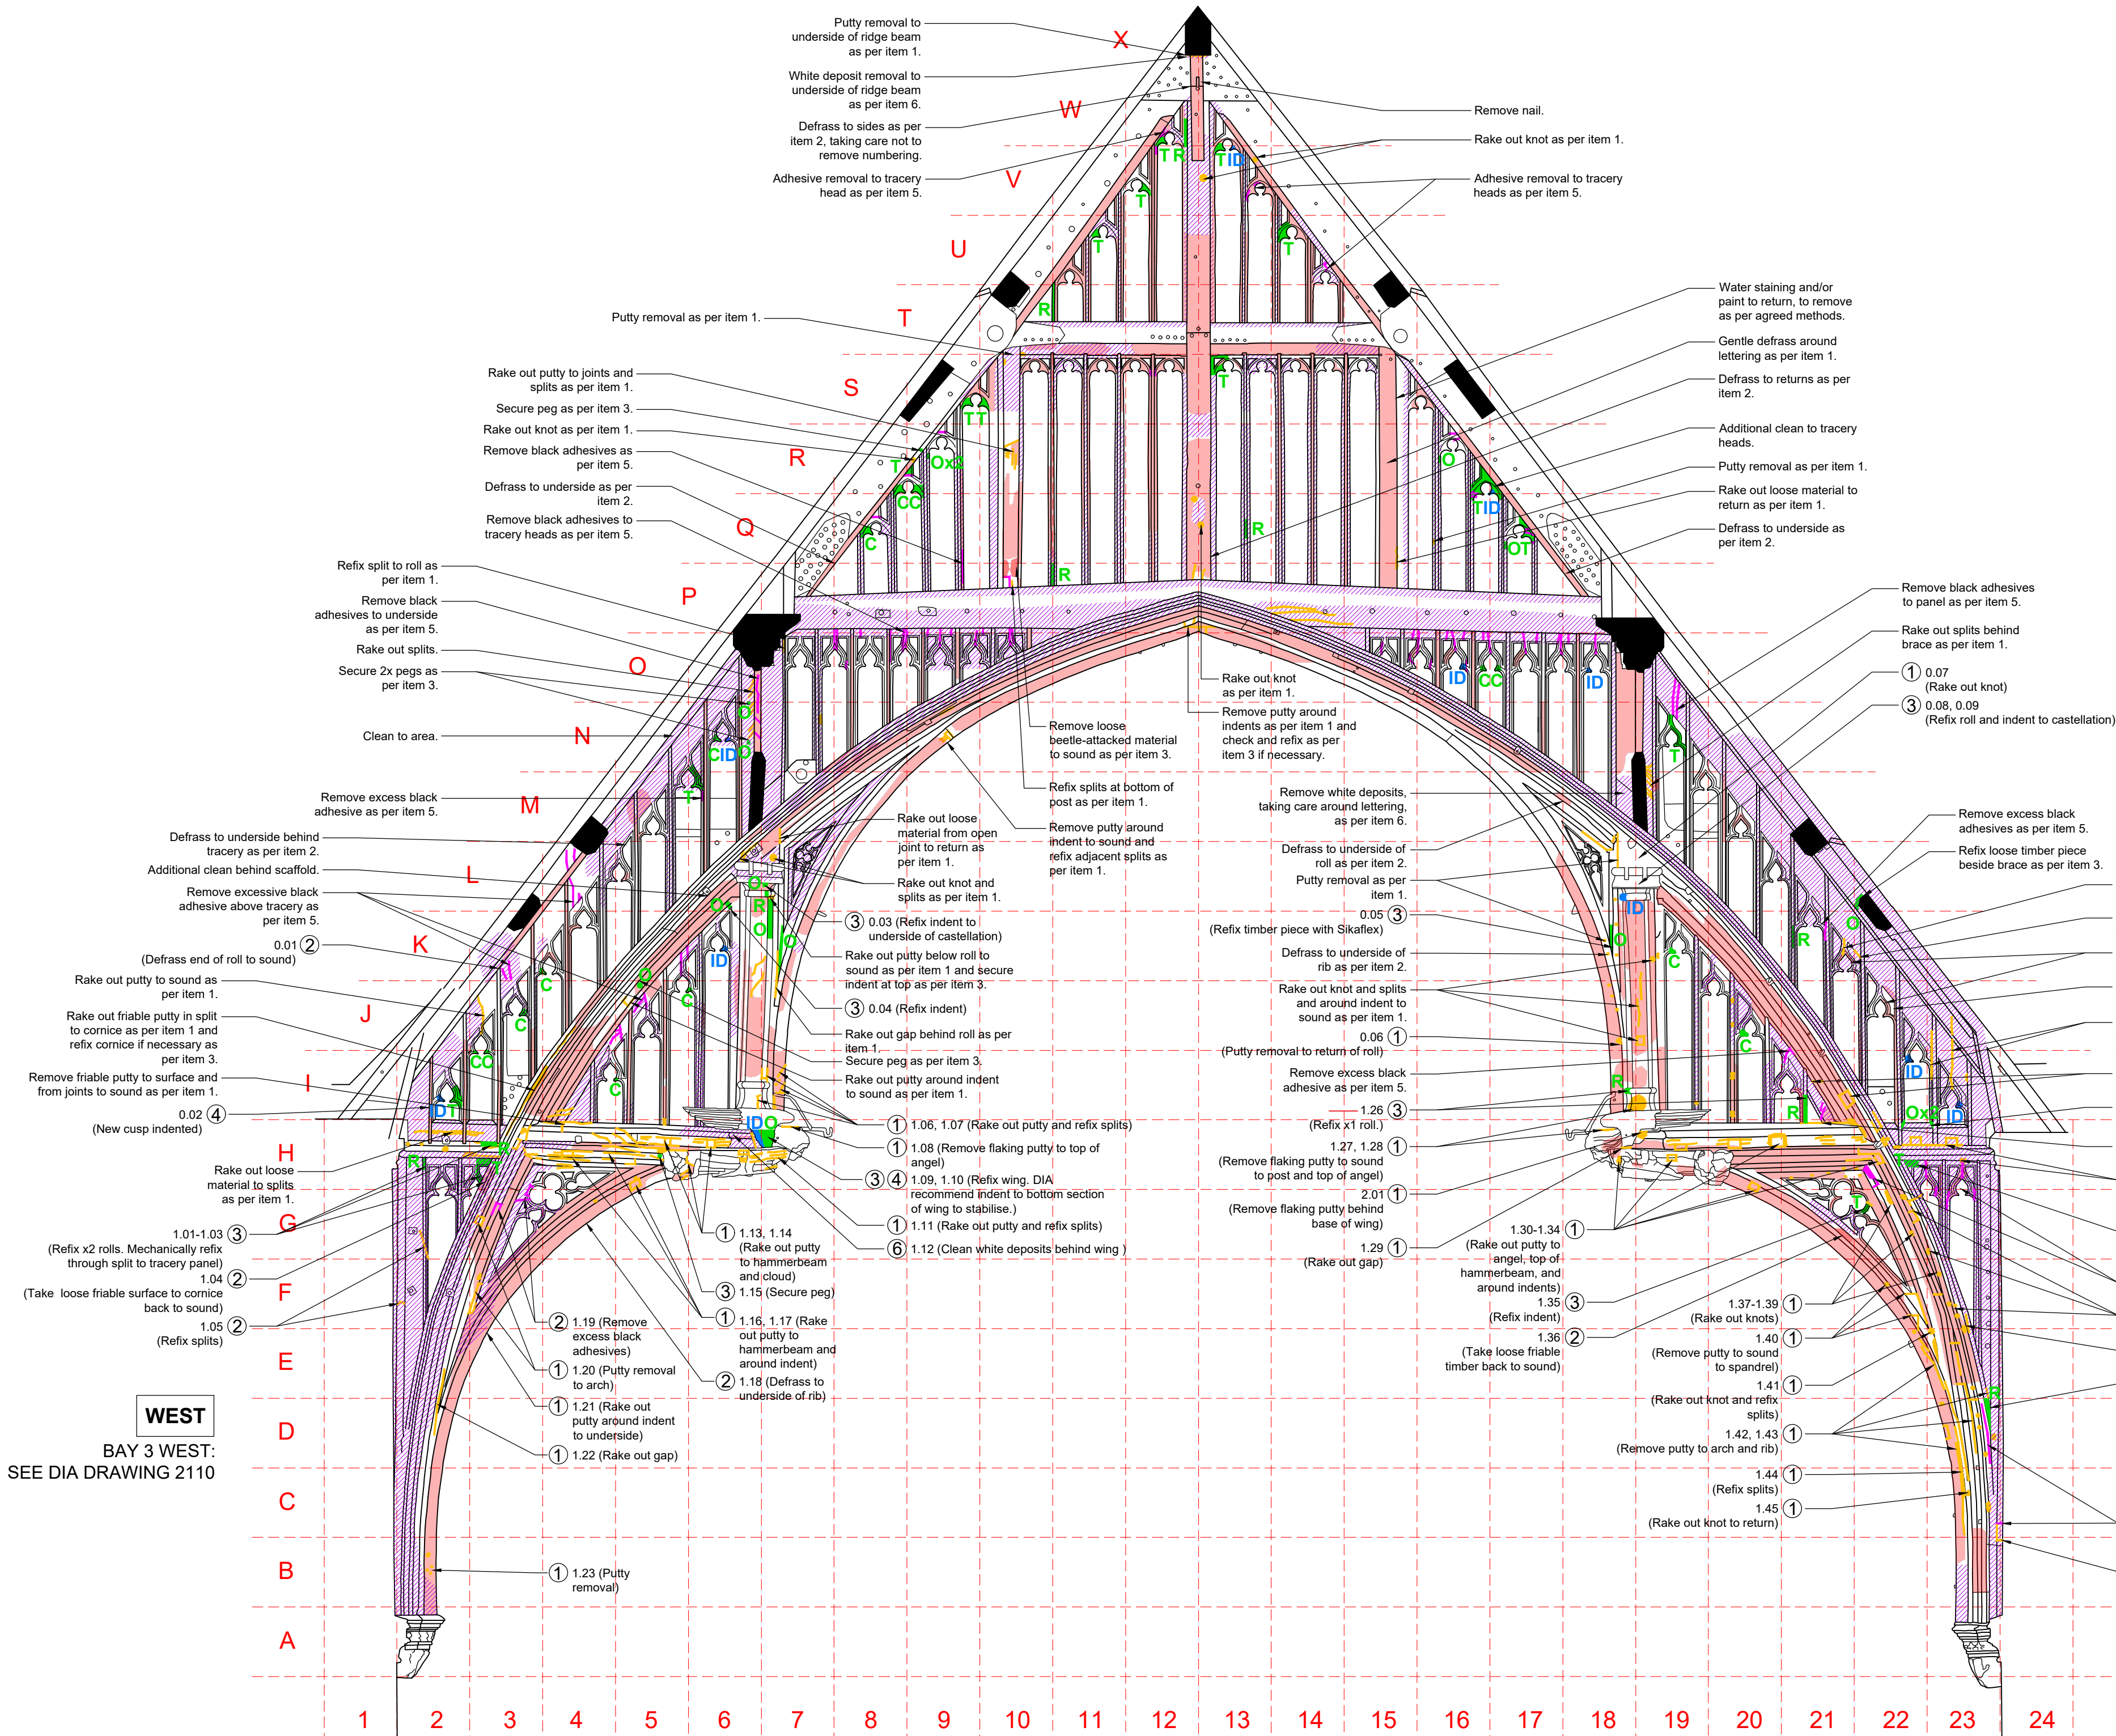
1 North Elevation of Bay 3 Roof Truss  
1:50

| REPAIRS KEY: | | |
|---|---|---|
| 1 | Splitting and feathering of timber along the grain. <ul style="list-style-type: none"><li>'D' denotes where split has caused timber pieces to detach, and require refixing.</li></ul> | Secure split / feathered timber as C53/150. Where splits contain putty or friable filler, rake out old / failed putty and leave open. <i>Where timber pieces have detached; refix where shown, otherwise safely remove.</i> |
| 2 | Beetle attacked / friable or sulfur decayed surface to timber. | Dust and remove loose timber to surface (defrass). Where decay is approx 4mm> deep, consolidate surface as C53/340. |
| 3 | Loose timber pieces. <ul style="list-style-type: none"><li>'T' denotes tracery.</li><li>'C' denotes cusp to tracery.</li><li>'R' denotes nosing or roll.</li><li>'O' denotes other (inc. old indents); <i>refer to annotation.</i></li></ul> | Secure loose timber / pieces (including previous indents) as C53/150 and C53/360. <i>Flat head screws to be used for securing rolls and other projections (cusps, tracery), fixed with screw head facing upwards, and as per DIA Specifica</i> |
| 4 | Missing or severely decayed timber. <ul style="list-style-type: none"><li>'ID' denotes indent.</li><li>'W' denotes whole replacement.</li></ul> | Indent or replace (i.e. missing cusps) in oak, as C53/150. Any cutting out to be kept to minimum feasible amount. |
| 5 | Adhesive/s to timber. | Remove excess adhesive, as per method agreed following trial sample (C53/80). |
| 6 | White spray deposits to timber and metalwork. | Undertake a light damp sponge clean (as per trial sample) to remove white spray deposits. |

**Allowance for Additional Defrassing:**  
Contractor to allow to defrass an additional 10% of the timber surface area, in order to allow for timber faces not shown on this elevation (tops, rears, sides and concealed faces of timbers, etc), as agreed with the architect on site.
