**Donald Insall Associates**  
Chartered Architects and Historic Building Consultants

Westminster Hall Lantern

Joinery Repairs to Internal Vaulting

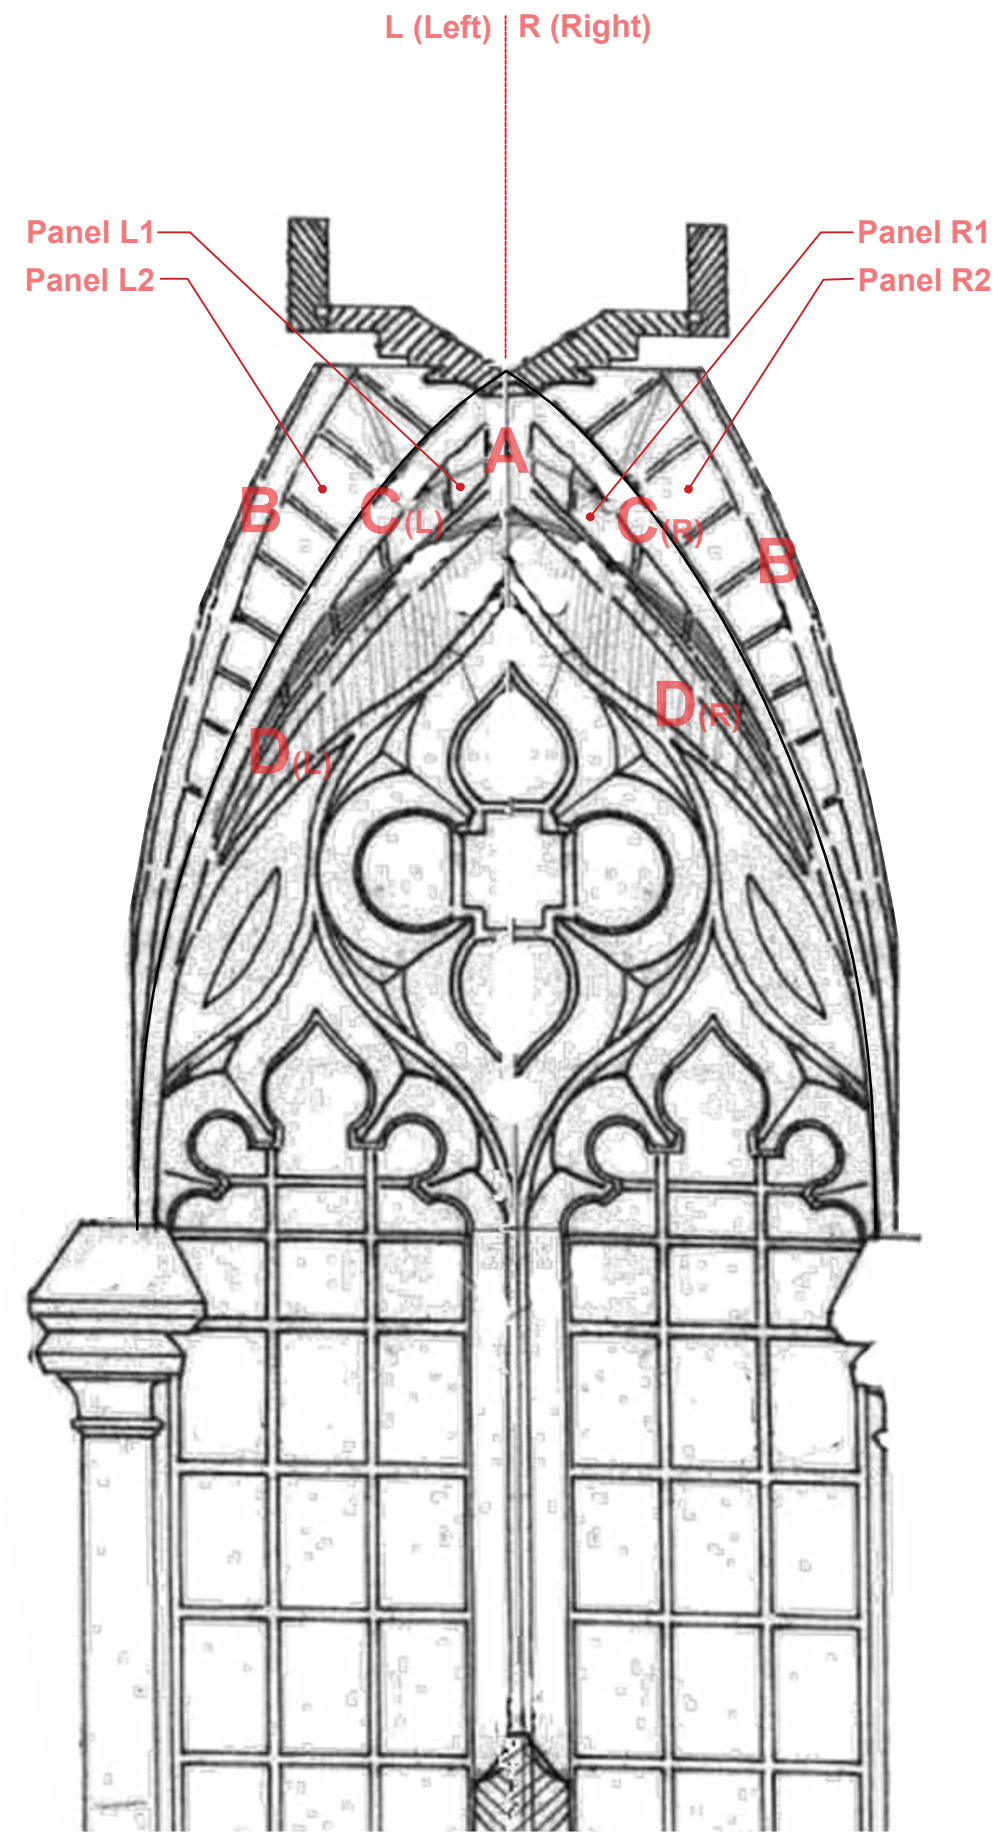
Grey area indicates central oak boss and surrounding hexagon. To be left in situ. Advise PM if any defects or loose parts are identified.
