## Europa Nostra Awards 2024 – response to additional question of 18<sup>th</sup> March 2024 (Westminster Hall)

Issued 25<sup>th</sup> March 2024

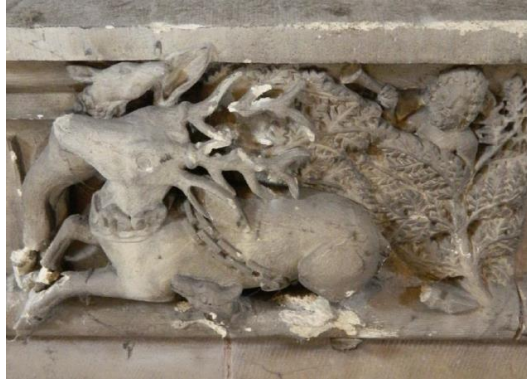
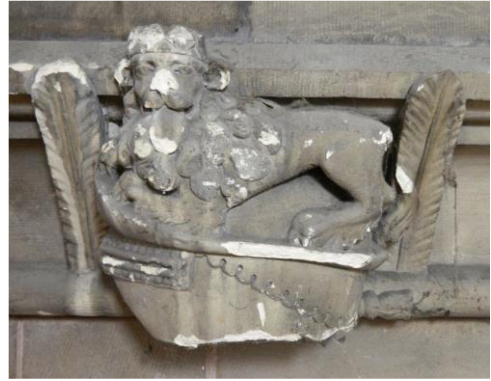
The below images show the three stages of work to typical carvings: before cleaning, after cleaning, and after shelter coating.

Before  
cleaning

The carvings were generally cleaned with laponite / clay / ammonium carbonate poultices (rather than the Arte Mundit latex product which was used on ashlar, cornices, and similar). This was typically made up of 8-10% ammonium carbonate solution and a mixture of sepiolite clay and paper pulp (1:1 or 5:3 ratio) to give a relatively dry poultice. This was applied to the surface, covered with clingfilm and left for up to 2 hours (contact time varied depending on the extent of dirt). After removal of the poultice, the surface was rinsed with clean water using a microporous sponge, bristle brushes and lightly misted if required.

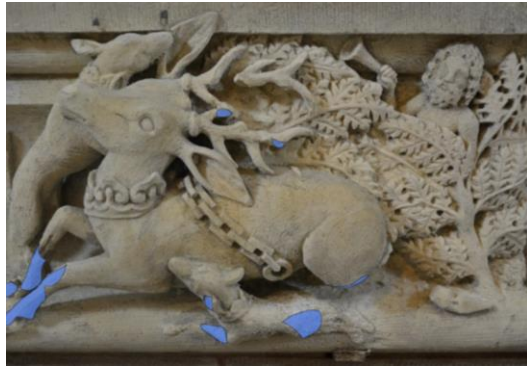
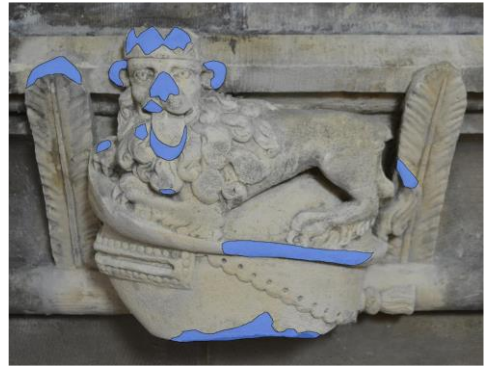
Recording  
areas of  
mortar  
consolidation

Where necessary, fine cracks and fissures were consolidated using CalXnova lime injection mortar. Larger repairs used traditional lime mortars, made with dispersed lime putty (as the lime compounds in DHL carbonate significantly faster because the surface of the lime is increased by dispersion). Mortars were typically 1:1:1 silver sand, Bath dust, Portland dust, dispersed lime putty.

Reports were prepared for each bay, recording exact conservation treatments per carving and mapping the locations of consolidation and mortar repairs. Paint analysis was undertaken in advance; traces of historic lime wash were found, but very little paint or gilding; exceptions include the medieval figures above the medieval treasury door and the north door. In these instances, the polychromy was mapped, and no shelter coat was applied.

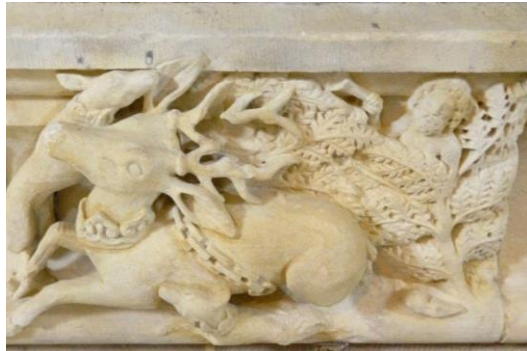
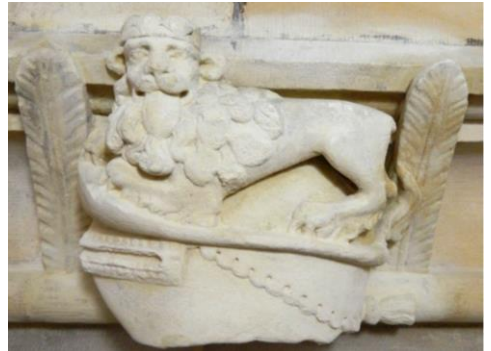
After  
consolidation  
and lime  
shelter coat

The shelter coat had several benefits such as filling the pores of the stone to reduce accumulation of pollutants in the pores, reducing the potential for damage to the stonework from condensation and finally by homogenising the surfaces to make the carving appear more consistent with the original architectural intention.

The shelter coat was based on dispersed lime; due to the very fine pore structure of the magnesian limestone, the aggregates to be mixed with the lime will need to pass through a very fine sieve (<300 µm). Mixes were typically 1:2 putty and Bath stone dust, with Portland dust, Ham stone dust and raw sienna used to adjust colouring to suit. The shelter coat was applied to pre-wetted stone and well worked into the surface. After ten to fifteen minutes, the surfaces were further stippled with a bristle brush and then allowed to dry / carbonate slowly. Once it had dried, excess material was removed by brushing. Where appropriate a base coat, a shadow / recess coat, and a final coat for high relief detail was used, to maintain visual depth.
