Job WESTMINSTER HALL CONSERVATION PROJECT
Title WEST ELEVATION BAYS 5-8: REPAIRS

Job PW.WH3	Status C
No 2010	Rev C
Scale (A1)	1:50

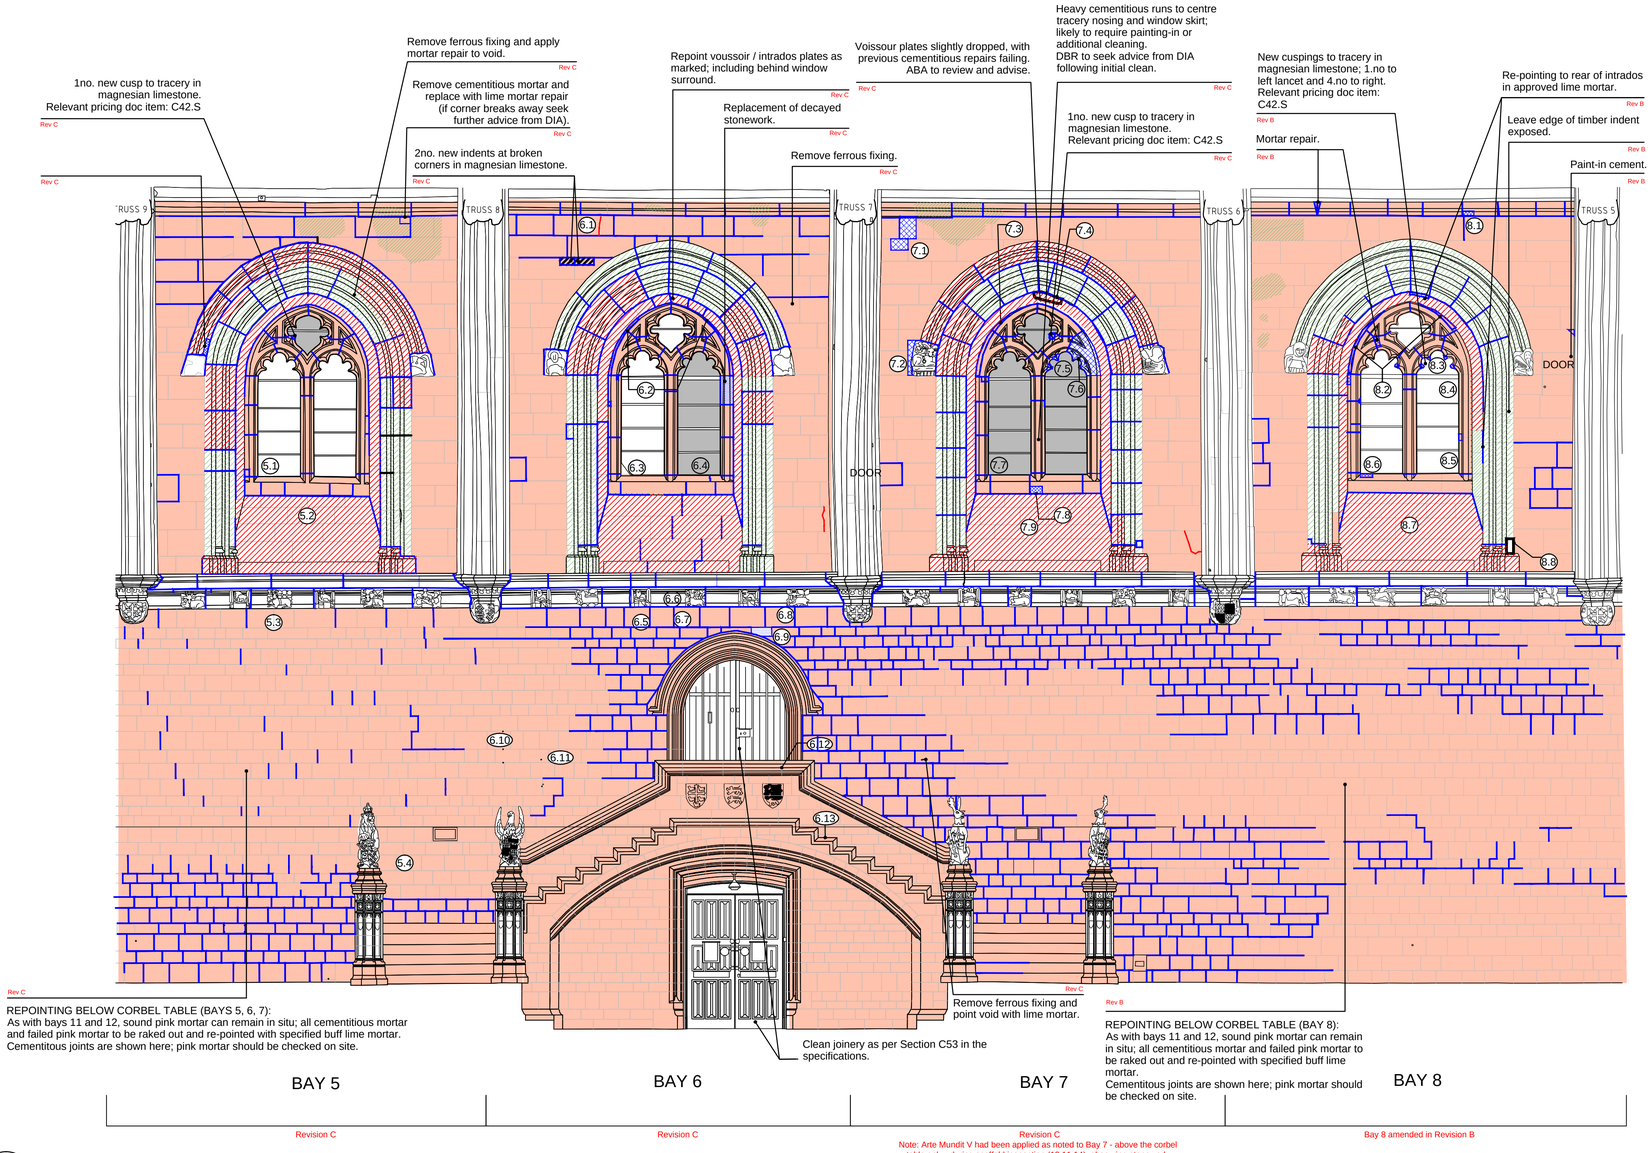
1
2010
West Elevation Bays 5-8
1:50

Rev	Date	Dwn	Auth	REVISIONS
C	12/11/14	ERL	ARR	REVISIONS TO **BAYS 5, 6, 7 ONLY** FOLLOWING SITE VISIT (SCAFFOLD ACCESS) - MOSTLY REPOINTING, PLUS NOTED REVISIONS 'C' ON DRAWING.
B	29/10/14	ERL	ARR	REVISIONS TO **BAY 8 ONLY** FOLLOWING SITE VISIT (SCAFFOLD ACCESS) - MOSTLY REPOINTING, PLUS NOTED REVISIONS 'B' ON DRAWING.
A	24/01/14	ARR	PXD	CONSTRUCTION ISSUE
-	20/13/13	ARR	PXD	TENDER ISSUE

- Remove existing loose or disfiguring mortar and re-point as C42/506 using lime mortar to match approved sample as Z21.
- Remove loose surface with a stiff/ soft bristle brush as C42/120. Brush back to sound surface and seek further instructions.

- Clean stone surfaces using 1No. applications of Arte Mundit V, as C40/500-510 for review. Further cleaning may be required and will be instructed by the PM if necessary.

- Remove loose surface with a stiff/ soft bristle brush as C42/120. Brush back to sound surface and seek further instructions. Following completion, clean stone surfaces using 1No. applications of Arte Mundit V, as C40/500-510 for review. Further cleaning may be required and will be instructed by the PM if necessary.

- Clean stone surfaces using 2No. applications of Arte Mundit V, as C40/500-510 for review. Further cleaning may be required and will be instructed by the PM if necessary.

- Remove loose surface with a stiff/ soft bristle brush as C42/120. Brush back to sound surface and seek further instructions. Following completion, clean stone surfaces using 2No. applications of Arte Mundit V, as C40/500-510 for review. Further cleaning may be required and will be instructed by the PM if necessary.

- Clean stone surfaces using 2No. applications of Arte Mundit V and one application of Laponite poultice for review. Further cleaning may be required and will be instructed by the PM if necessary.

- Cut out decayed or damaged area of existing stone and repair with stone indent.
- Cut out decayed existing stone in its entirety and replace with new stone.

- Remove existing glazing and reinstate on completion of masonry repairs.
- Cracks in existing stonework to be pinned as noted on drawing.
