| Job | WESTMINSTER HALL CONSERVATION PROJECT | Status | C |
| Job No. | 2003 | Rev | K |

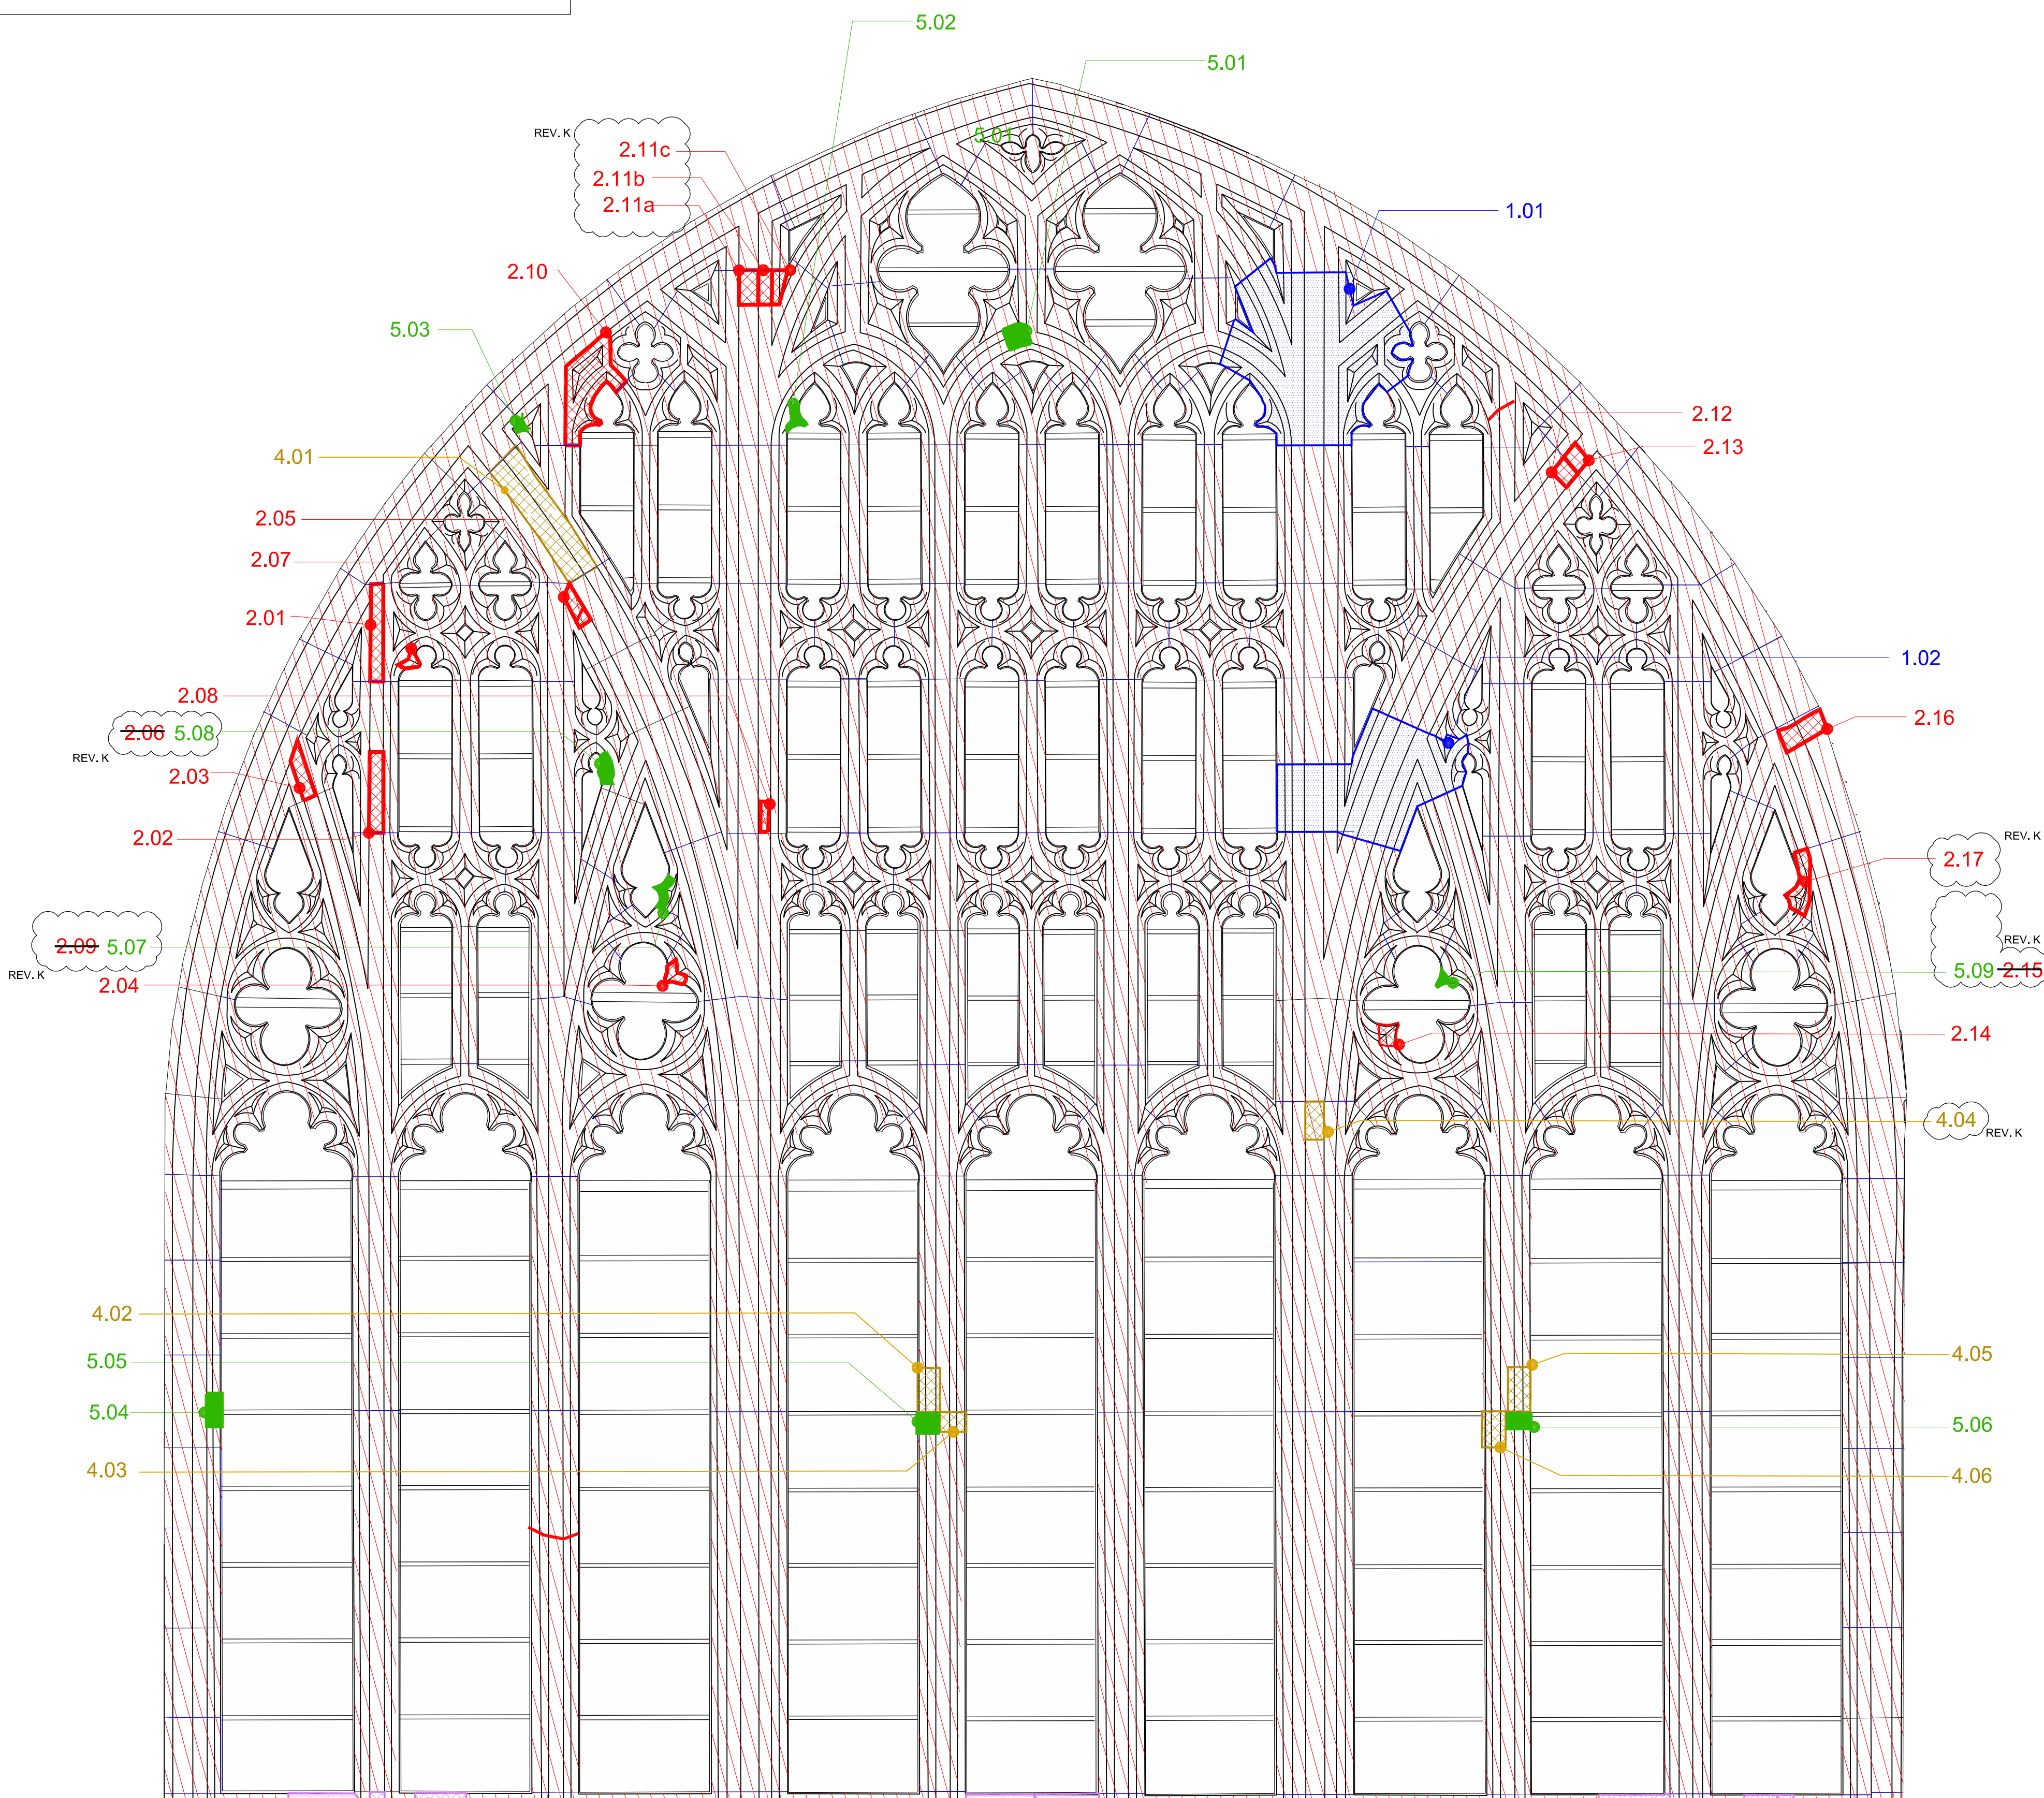
Cracks in existing stonework to be repaired as annotated.

Magnesian Limestone full stone replacement

Magnesian Limestone stone indent

Bath Stone full stone replacement  
(N.B. stone indents to transoms)

### Bath Stone indent

## Plastic Repair

See DIA Drawing 2004 for Part 2 of the North Internal Tracery

Remove existing loose or disfiguring mortar and re-point as C42/506 using lime mortar to match approved sample as Z21.

Remove loose surface with a stiff/ soft bristle brush as C42/120. Brush back to sound surface and seek further instructions.

Clean stone surfaces using a single application of Arte Mundiit V, as C40/500-510. A secondary application of Laponite may be required and will be instructed by the Project Manager if necessary.

Carefully remove glazing panel and set aside for reinstatement as L50/51.

1. Refer to carved stonework repair schedule for works to the frieze, label stops and heraldic beasts.
2. All glazing to be removed by glazing specialist and reinstated on completion of masonry cleaning and repairs.
